Home Inspection Report

123 Sample Street

Anytown, CA

July 01, 2014

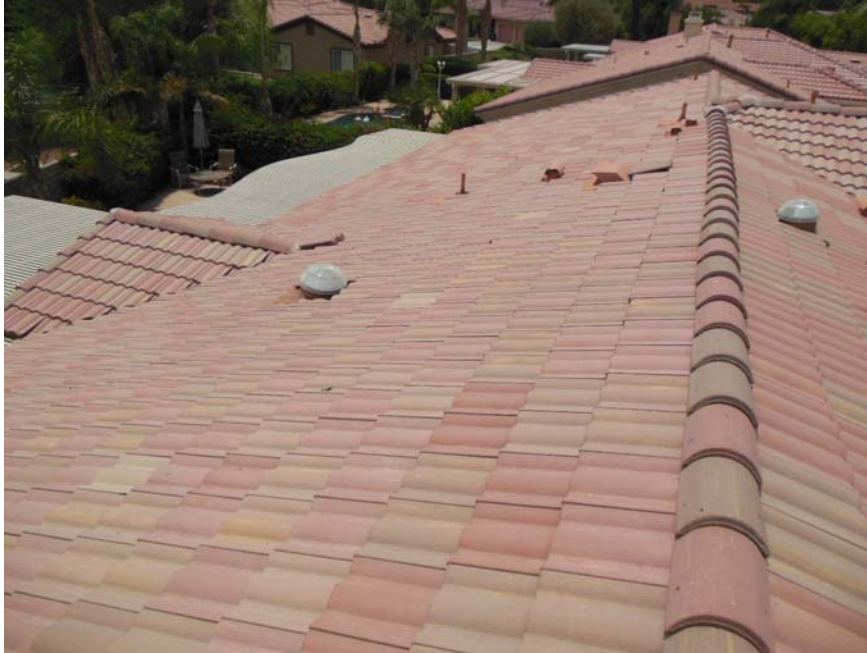
Typical roof view. The roof appears to be well constructed and is in good condition.

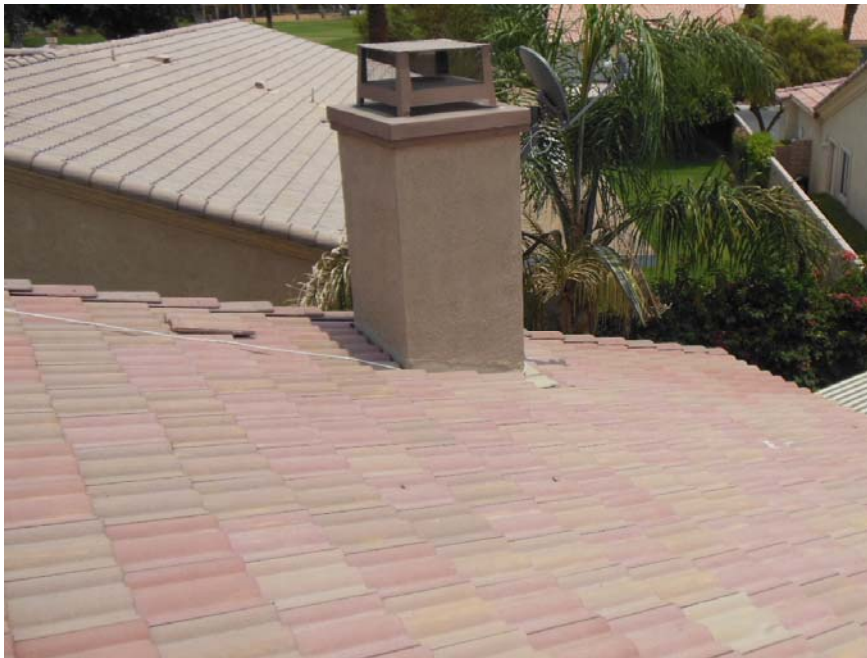
Another roof view also showing properly installed chimney, spark arrestor and rain cap. No roof leaks or defects were evident.

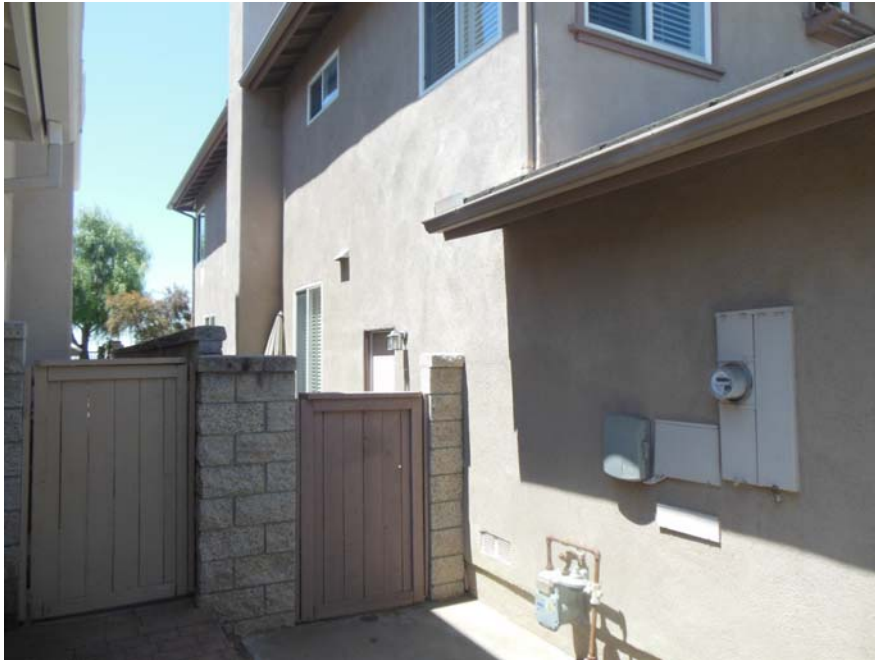
Exteriors of the home are also in good condition. The stucco, trim, window systems, drainage and other exterior systems were all found to be in conformance with industry standards.

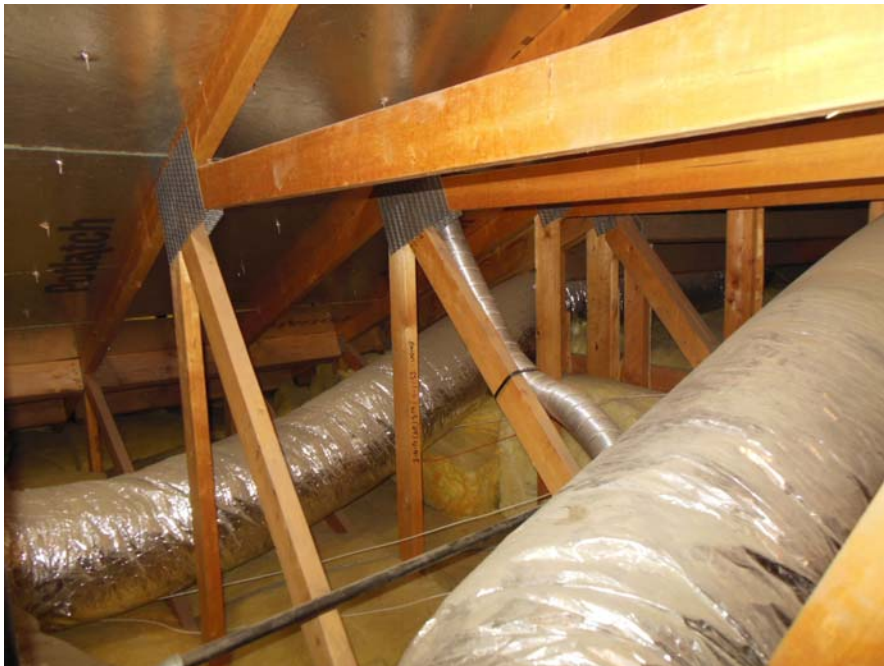
Roof framing and attic related systems also appear to be in good condition.

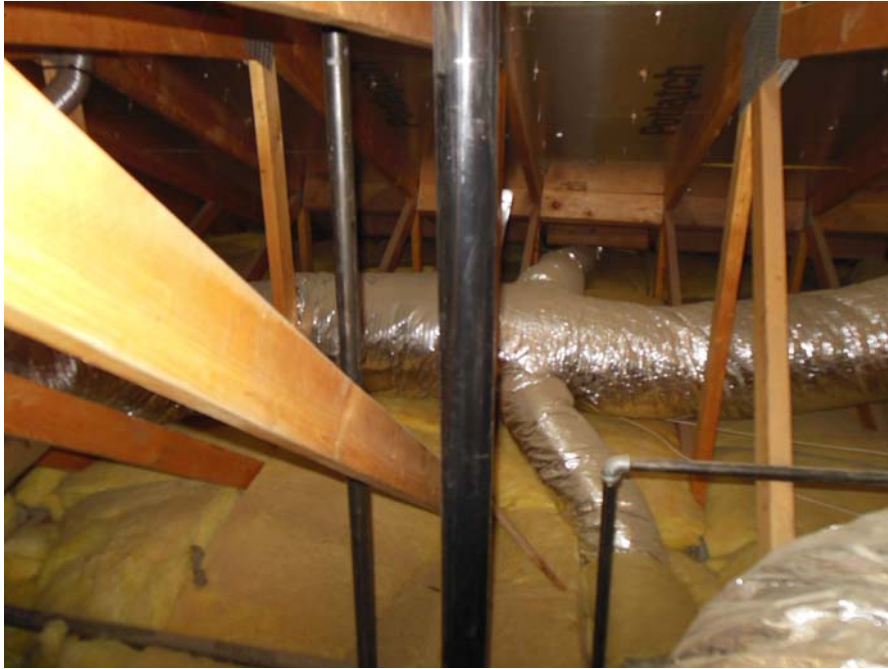
Another attic view. Note neatly and good quality heating and cooling duct systems installation.

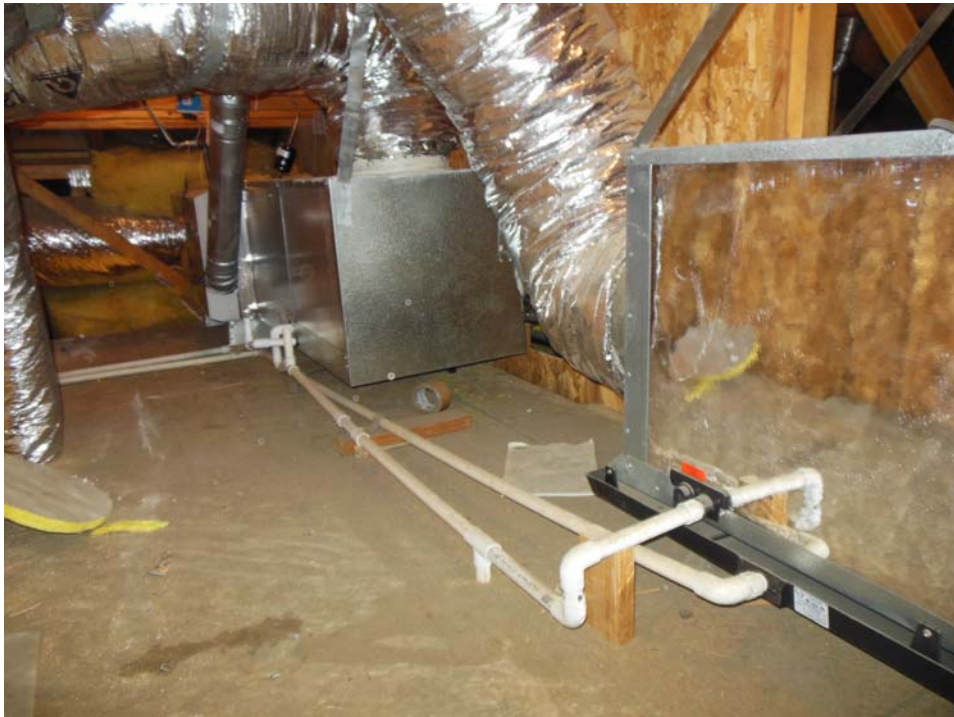
View of good quality and neatly installed Carrier brand HVAC units in attic space. Both units came on in heat mode and were also cooling properly in cooling mode. The installations are neat and tidy.

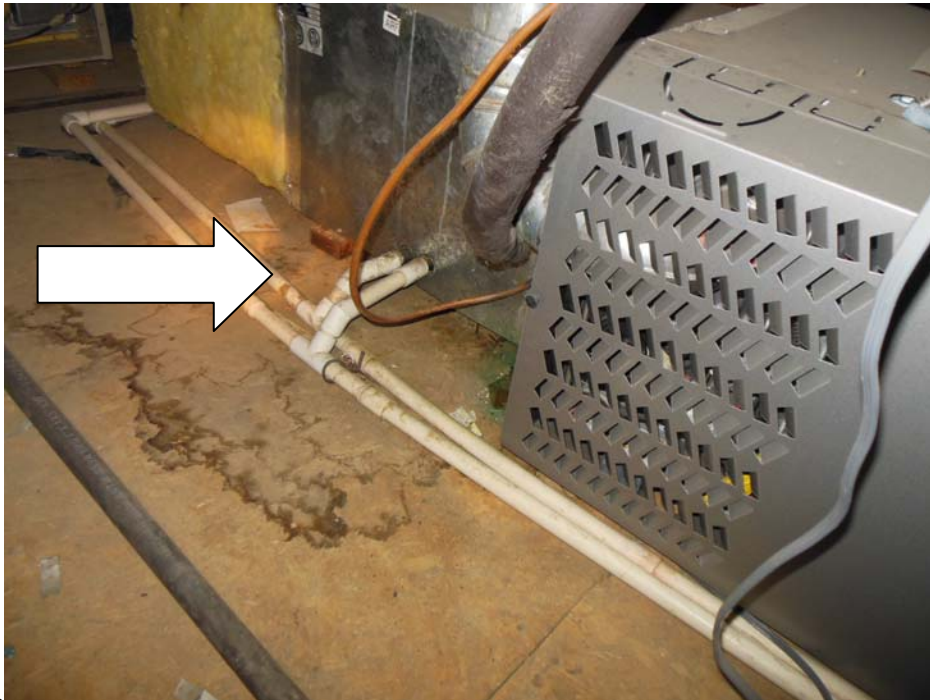
- 7) The condensate drain line at the second unit in the attic is leaking. This should be an easy repair as it can be seen where the plastic pipe fitting is not properly connected. See photo. Units are located in attic accessible through master bedroom walk in closet.

This is where the condensate drain line is recommended for repair. We could see where water was dripping from the disconnected fitting indicated by the arrow.

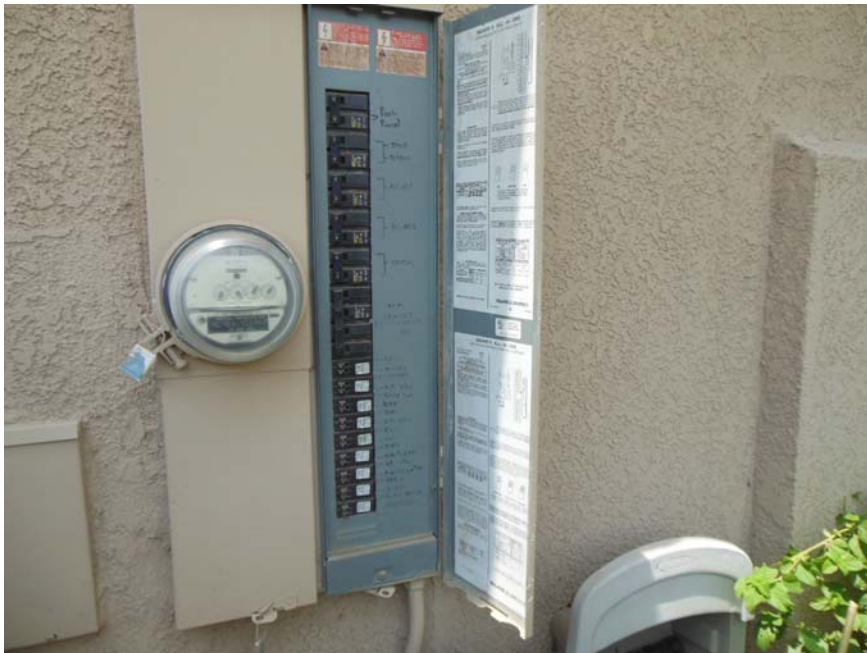
Electrical meter section and breaker panel is good quality and is neatly installed. No electrical defects were noted.

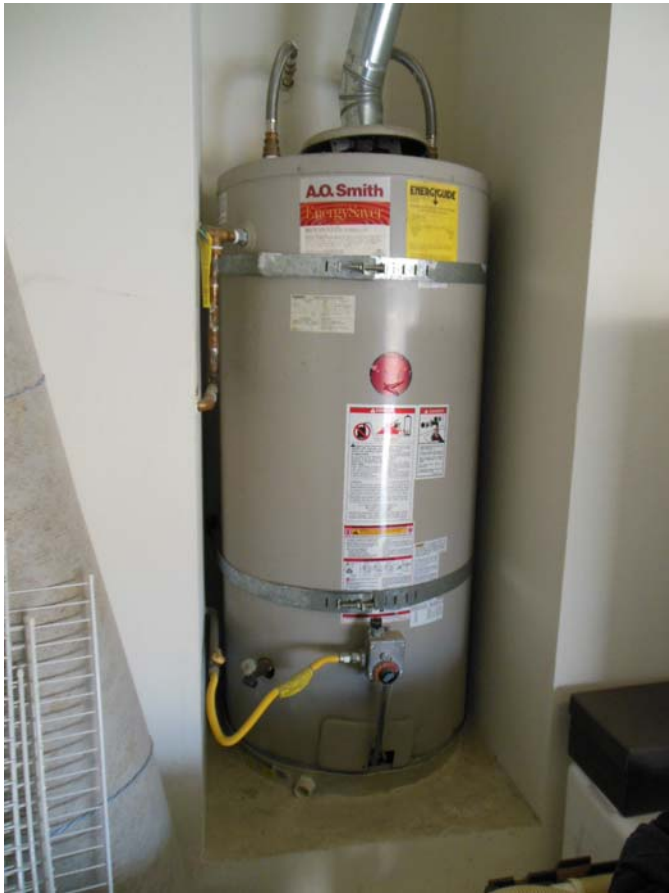
Water heating and plumbing systems are also good quality and in good condition.

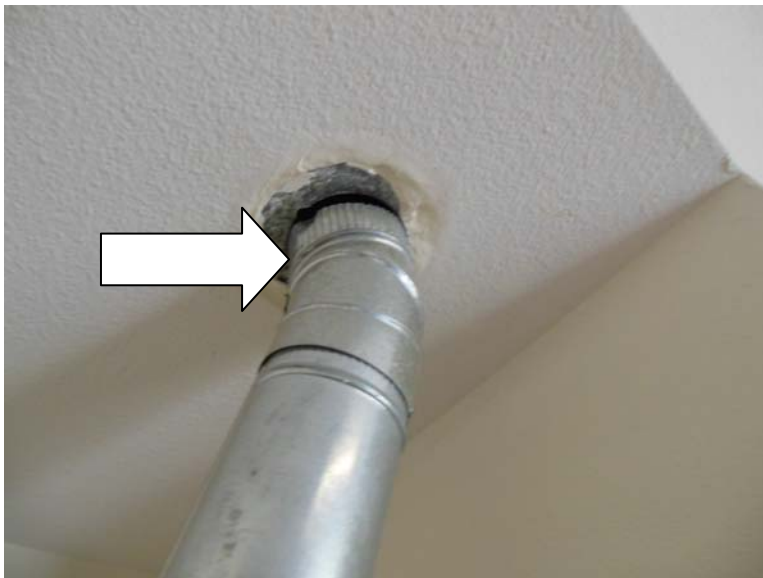
Water heater flue needs to be properly connected at collar at ceiling above. A minimum of two mechanical fasteners (sheet metal screws) are required to hold it safely fast.

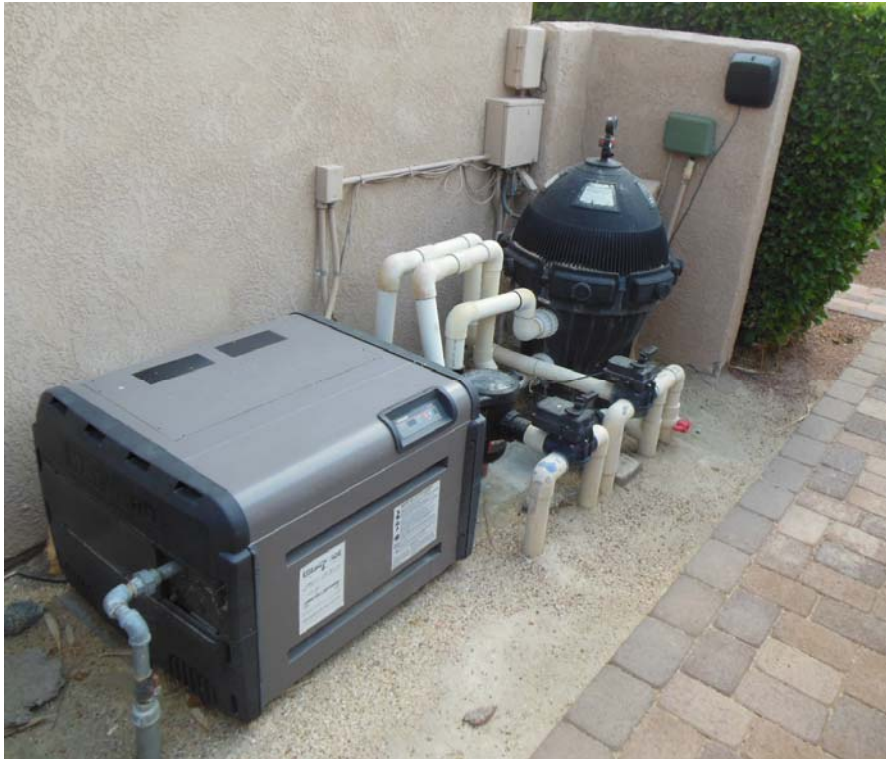
Pool equipment is good quality and all functions were operational; pumps, spa, heater, pool and spa lights etc. all functioned normally.

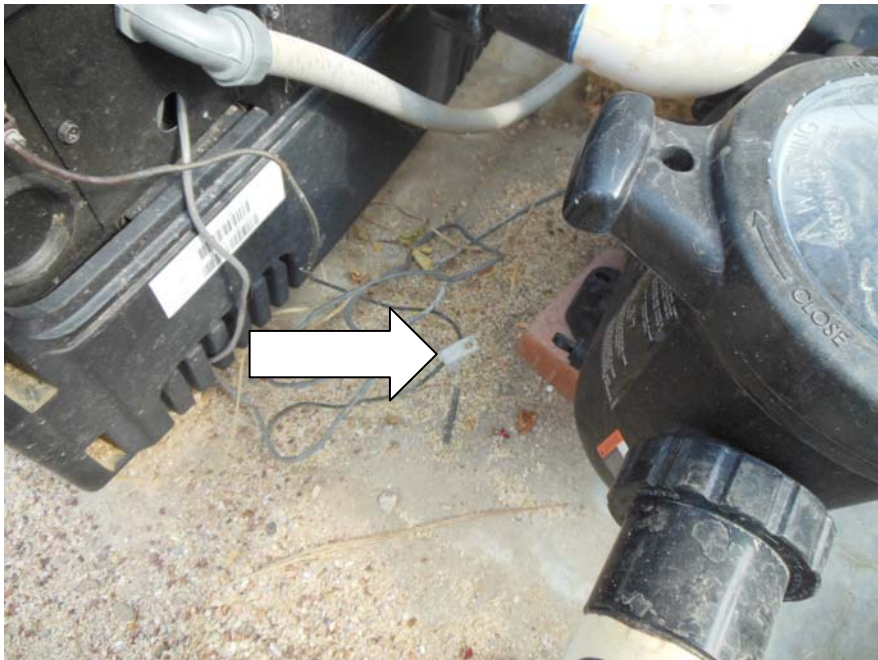
- 10) The electrical bonding (grounding) systems do not appear to be properly connected to all of the equipment as required for safety. See photo below showing copper wire is disconnected from the pool pump.
- 11) Recommend for the breakers in the pool electrical subpanel to be labeled for safety and convenience.

Electrical bonding (grounding) wire needs to be re-connected to the motor. Arrow indicates ready-made lug. Fastener is missing. This is an easy but important repair for safety.

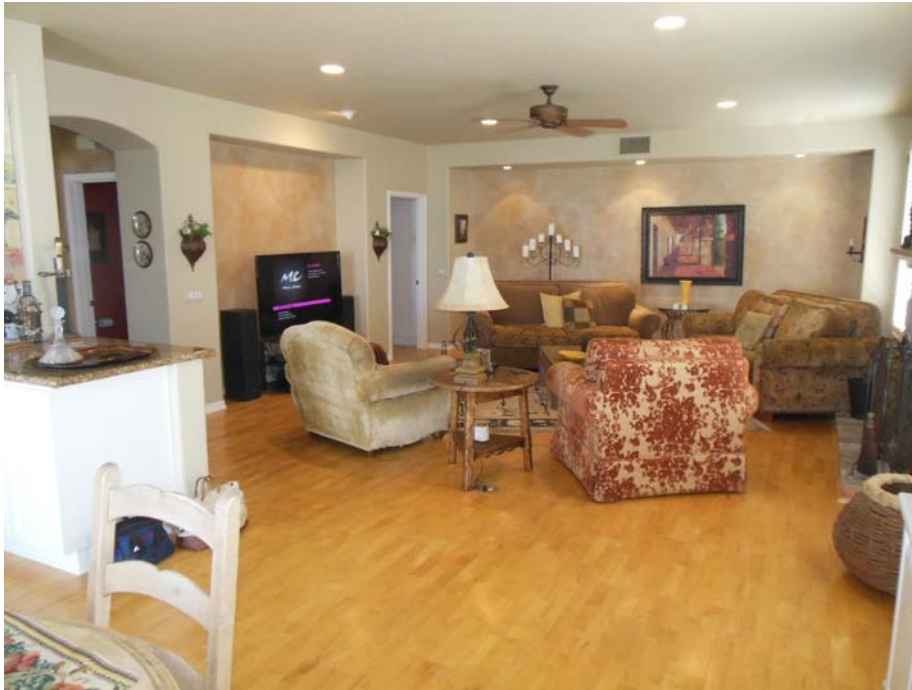
Interiors of the home are also in good condition and appear to be well maintained.
